Subject: **Schools Out Until Fall – MAYBE?**

Project: Barber Hill ISD

Resilient Flooring: VCT

Project Size: 13,500sf VCT - August 2015

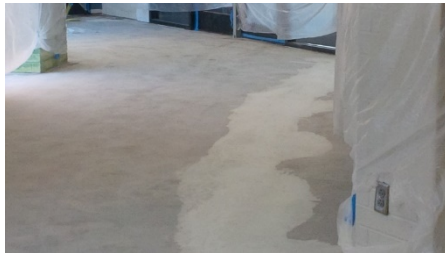
After CSP – 1 w/ Aquaflex Waterproof Patch

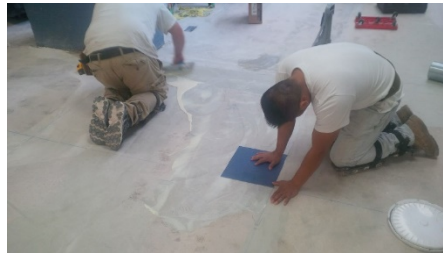
Troweling Aquaflex | Starting Point in Corridor Intersection

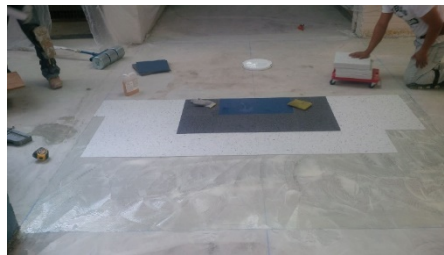
Completed Corridor Section

Before stripping of factory finish and application of floor finish.

Additional trade activity, furniture movement from classrooms, etc.

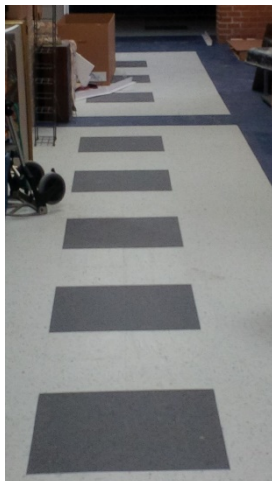
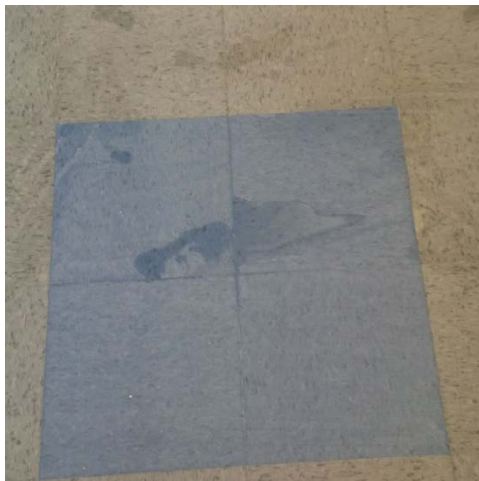
Corridor section stripped of factory finish

Clean water rinse

Standing water throughout the areas

Visible moisture penetration of the tile seams and absorption

- Factory finishes stripped, clean water rinse prior to application of floor finish.
- Standing water, tile seams have absorbed moisture from standing water.
- Important added benefit of the Aquaflex topical moisture protection.
