2-Part Epoxy Coatings & Osmotic Blisters

A problem with 2-part epoxy sealants as a strategy
for mitigating elevated MVER in concrete

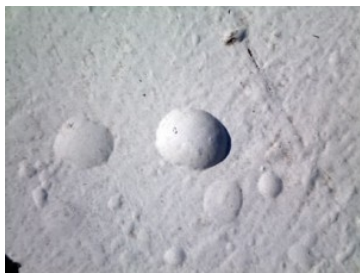
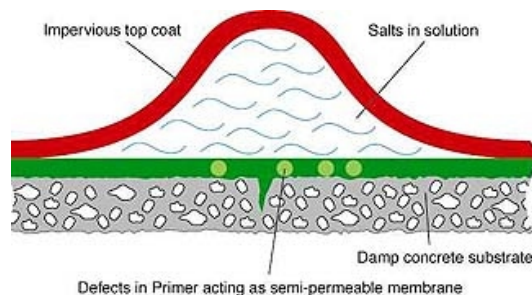
So what about these blisters? Well, blisters form when the flow of water into the laminate boundary exceeds the flow of hydrolysis fluid back out. It is that simple, FLOW IN EXCEEDS FLOW OUT. To understand technically what happens, we have to understand osmosis and osmotic theory.

As stated earlier, when two fluids are separated by a semi-permeable membrane and one is more concentrated than the other, the more concentrated will draw the less concentrated solution through the membrane until the two are of equal concentration. The force that does the "drawing" is called "osmotic force" and it can be substantial. So how does this relate to blister failures of
